JACKAROO TIP

Low Power & Black Smoke

Vacuum Hose Replacement

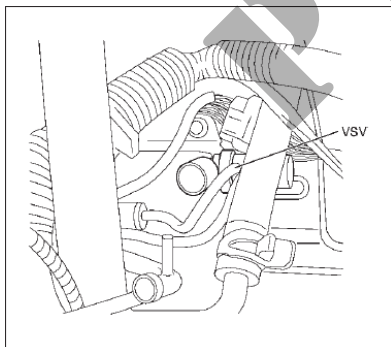
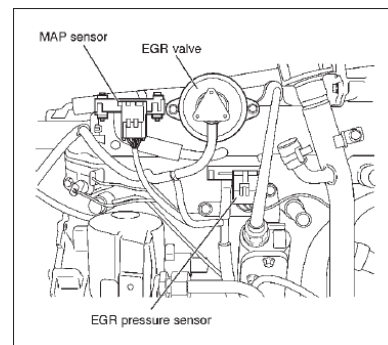
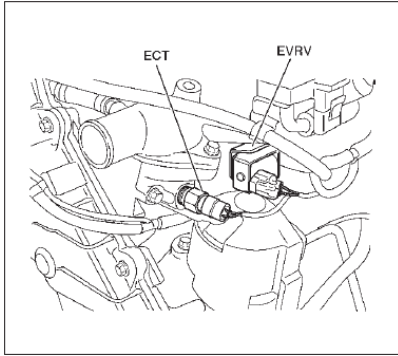
If your 4JX1 Jackaroo is suffering low power under acceleration and blows some black smoke then check that the vacuum hoses to the Exhaust Gas Recirculation Valve (EGR), Manifold Absolute Pressure sensor (MAP) and Vacuum Switching Valve (VSV) are OK. Over time these hoses become hard and brittle, typically where they attach to other hot parts. Vibration leads to the hoses cracking and allowing a loss of vacuum to the sensors. A visual inspection is not really conclusive and as a matter of course **all** hoses should be replaced. Note that there are two different diameters used. Suitable replacement hose can be purchased for a few dollars at your local motor parts store. Replace each, one at a time to ensure that you put it back in the correct place. With the engine running, check that there is vacuum in the lines by removing a hose and noting any change in engine revs. You should also be able to feel the vacuum with your finger on the exposed end of the hose.

The MAP sensor is critical to ensuring the correct fuel air mix. The sensor itself is generally found to be reliable for many years and the vacuum hose is the only problem. If the MAP sensor is not operating, the fuel mix may be too rich or too lean (depending on the engine temperature). Too rich and there will be black smoke! Generally NO fault code will be displayed if the MAP sensor has no vacuum. Fault code 34 will only show if there is an electrical failure of the MAP sensor.

The EGR valve is intended to capture fumes from within the engine and direct them into the inlet manifold. The EGR valve has been found to gradually seize up over time. This can be checked by "blipping" the throttle /accelerator and noting movement of the exposed shaft in the valve moving back and forth. If it doesn't move then remove the EGR valve and operate the shaft by hand while cleaning it. The diaphragm in the EGR valve is generally OK but if after cleaning and a vacuum is confirmed and the shaft still doesn't move then suspect the diaphragm. Generally NO fault code will be displayed if the EGR valve has no vacuum.

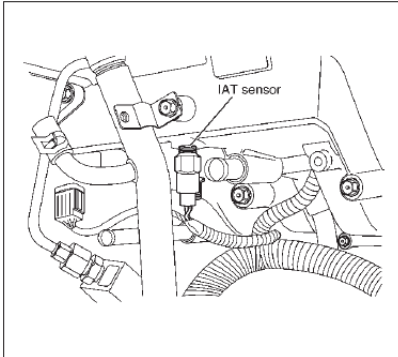
Another source of black smoke and over rich mixture is the slow operation of the Inlet Air Temperature sensor (IAT). This sensor is located on the underside of the inlet manifold and over time it gets covered in carbon and becomes ineffective particularly as the engine warms up.

When dirty, the sensor tends to register cooler inlet air than actual and hence the ECM computer provides a richer mixture than that needed thus causing black smoke.

Action. Remove the sensor and check for carbon build up. Typically, cleaning the IAT will give some improvement but ideally the manifold should be removed and cleaned internally to remove the carbon around the sensor. Generally NO fault code will be displayed if the IAT sensor is dirty. Fault code 23 will only show if there is an electrical failure of the IAT sensor.
