JACKAROO TIP

Turbo Diesel - Black smoke exhaust

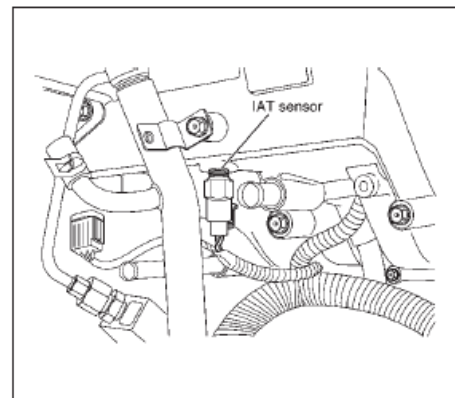
A crucial sensor that is often found to cause a rich mixture, is the Intake Air Temperature Sensor (IAT). This is located on the lower part of the inlet manifold as shown. Over time, the inside of inlet manifold builds up with oil and carbon, this will gradually coat the IAT and reduce its effectiveness to measure the air temperature, particularly as the IAT is on the lowest side. Thus, when a cold engine starts, the IAT takes time to recognise the increase in air temperature and continues to report "cold air" to the ECM and a rich mixture is maintained. Usually, there will NOT be a fault code. Removing the air hose

between the intercooler and the throttle body may provide an indication of the possibility of oil and carbon build up in the inlet manifold. If the throttle butterfly and its mounts are covered with oil and soot then the inside of the manifold and the IAT is almost certainly covered. A partial cure for a dirty IAT is to remove and clean it but this will not be a full cure. The best solution is to remove the manifold from the head and clean it using suitable degreasing solvents. Maybe pouring some volatile solvent in through the throttle throat and leaving overnight may be a benefit but it is essential that no liquids enter the cylinder bores as the hydraulic effect may damage the engine. Alternatively, some proprietary engine *tuneup/carburettor cleaners* may be poured into the throttle while the engine is running but it would probably take many litres over time to remove the build up of oil and carbon.
